Contract #: 04-0120F4Cty: SF/ALA Rte: 80 PM: 13.2/13.9File #: 69.28**WELDING INSPECTION REPORT****Resident Engineer:** Pursell, Gary**Address:** 333 Burma Road**City:** Oakland, CA 94607**Report No:** WIR-012086**Date Inspected:** 18-Feb-2010**Project Name:** SAS Superstructure**OSM Arrival Time:** 700**Prime Contractor:** American Bridge/Fluor Enterprises, a JV**OSM Departure Time:** 1900**Contractor:** Zhenhua Port Machinery Company, Ltd (ZPMC), Changxing Island **Location:** Shanghai, China**CWI Name:** Li Yang**CWI Present:** Yes No**Inspected CWI report:** Yes No N/A**Rod Oven in Use:** Yes No N/A**Electrode to specification:** Yes No N/A**Weld Procedures Followed:** Yes No N/A**Qualified Welders:** Yes No N/A**Verified Joint Fit-up:** Yes No N/A**Approved Drawings:** Yes No N/A**Approved WPS:** Yes No N/A**Delayed / Cancelled:** Yes No N/A**Bridge No:** 34-0006**Component:** OBG**Summary of Items Observed:**

TRIAL ASSEMBLY YARD

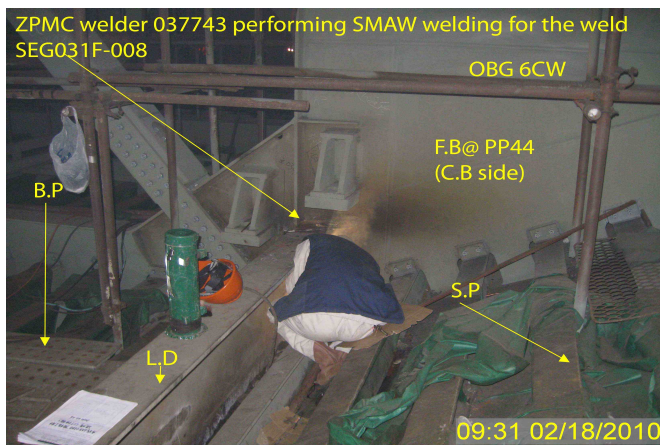
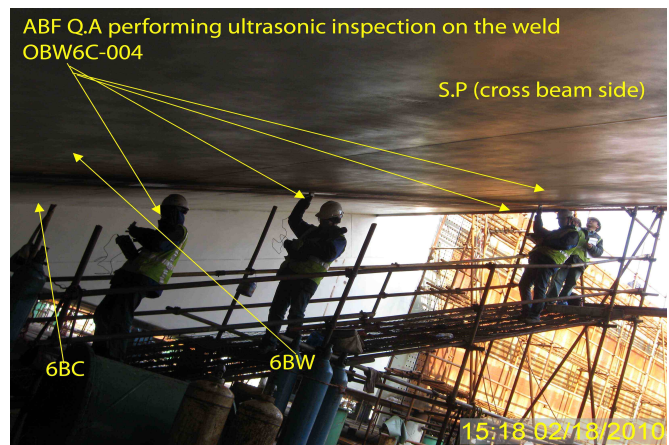
This Quality Assurance (QA) Inspector observed ZPMC qualified welder 037743 performing Shielded Metal Arc Welding process for weld SEG031F-008 located on PCMK weld between longitudinal diaphragm to floor beam at PP44 cross beam side. ZPMC QC Mr. Li Yang monitoring this welding. The welding variables recorded by QC appeared to comply with the WPS-345-SMAW-3G (3F) –FCM-Repair-1. Critical weld repair report identified as B-WR10630.

This Quality Assurance (QA) Inspector observed ZPMC qualified welder 037743 performing Shielded Metal Arc Welding process for weld SEG027F-008 located on PCMK weld between longitudinal diaphragm top flange to floor beam at PP40 cross beam side. ZPMC QC Mr. Li Yang monitoring this welding. The welding variables

recorded by QC appeared to comply with the WPS-345-SMAW-1G (1F) –FCM-Repair-1. Critical weld repair report identified as B-WR1067.
